Case study 2: Trees 2020 Nursery

Background:

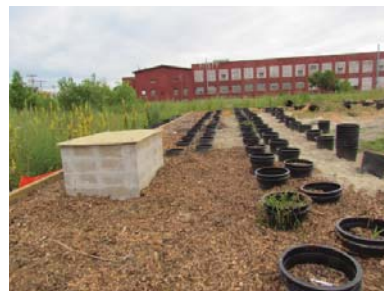
From Left: Orange visual barrier, 3/4" crushed stone drainage layer, 6-8" barrow material and insert/socket pot growing system.
